DAILY REPORT

PROJECT	San Jacinto River Waste Pits TCRA			CONTRACT NO.	
CONTRACTOR	USA Environment, LP		SUPERINTENDENT	Ron Griffith	
DAY OF WEEK & DATE:		Monday, May 16, 2011		REPORT NO.	104
WEATHER	Sunny, light wind from north			TEMPERATURE	L:65° H:85°F
<u>NUMBER/CLASS OF CONTRACTOR'S PERSONNEL:</u>			<u>MAJOR EQUIPMENT ON JOB (Size/capacity):</u>		
10 – USA Environment (USA) 10 – Shirley & Sons			<u>LaBarge Property</u> Komatsu PC300LC Excavator (2) Komatsu PC200LC Excavator Komatsu D61 Dozer Deere 624J Front-end Loader Deere 644J Front-end Loader Crane Work boat with winch		
			<u>TxDOT ROW/SJRWP</u> Cat Long Reach Excavator JCB Long Reach Excavator Cat 930 Loader Cat D5 Dozer Water Truck Barge-Mounted Excavator (2) 'Jim Dandy' Tug Boat Jon Boat Aggregate Transport Barge		
<u>TIDE INFORMATION:</u>			<u>HEALTH AND SAFETY INFORMATION:</u>		
Time:	Location:	Height (inches):	No incidents or near misses on this date.

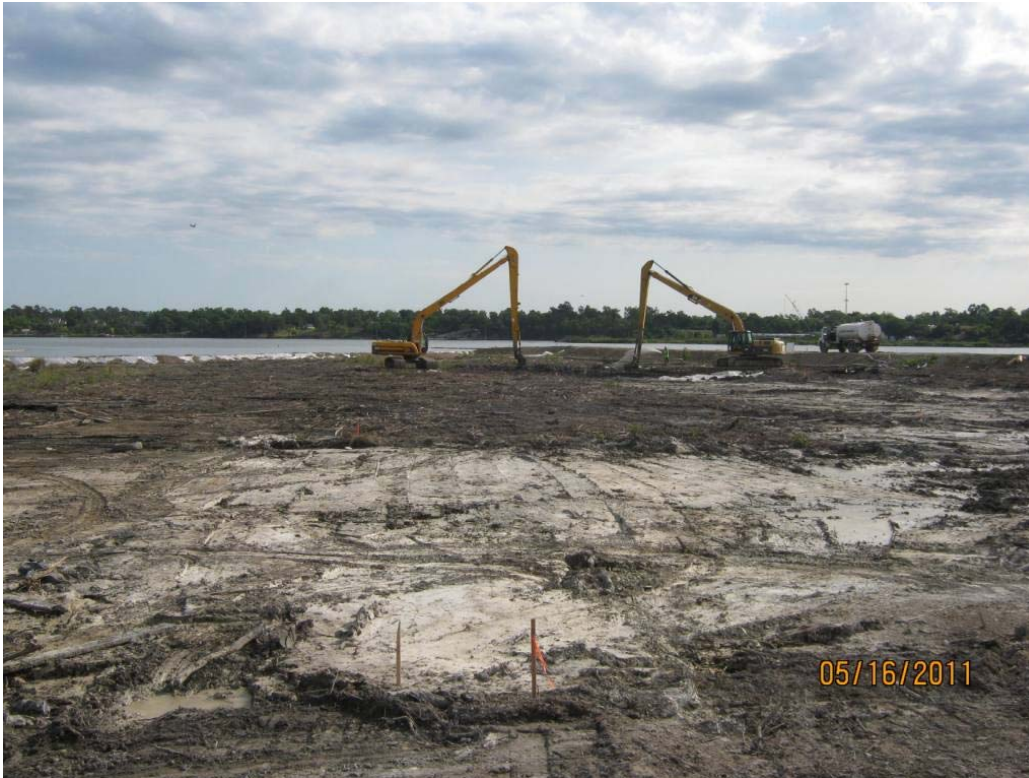
Photo 1 – Delivering Portland cement to the Western Cell and spraying with water hose to mitigate dust generation.

07:15 USA crew mobilized to the TxDOT ROW/SJRWP area.					
08:45 R. Brown mobilized to the TxDOT ROW/SJRWP area. Current activities: <ul style="list-style-type: none"> Placing Armor Cap D rock in the Eastern Cell (water-based operations) Unloading Portland cement from a truck into the Western Cell for stabilization of low-lying areas; dust generated by the unloading process has been generally minimal and is dissipating before reaching the south berm

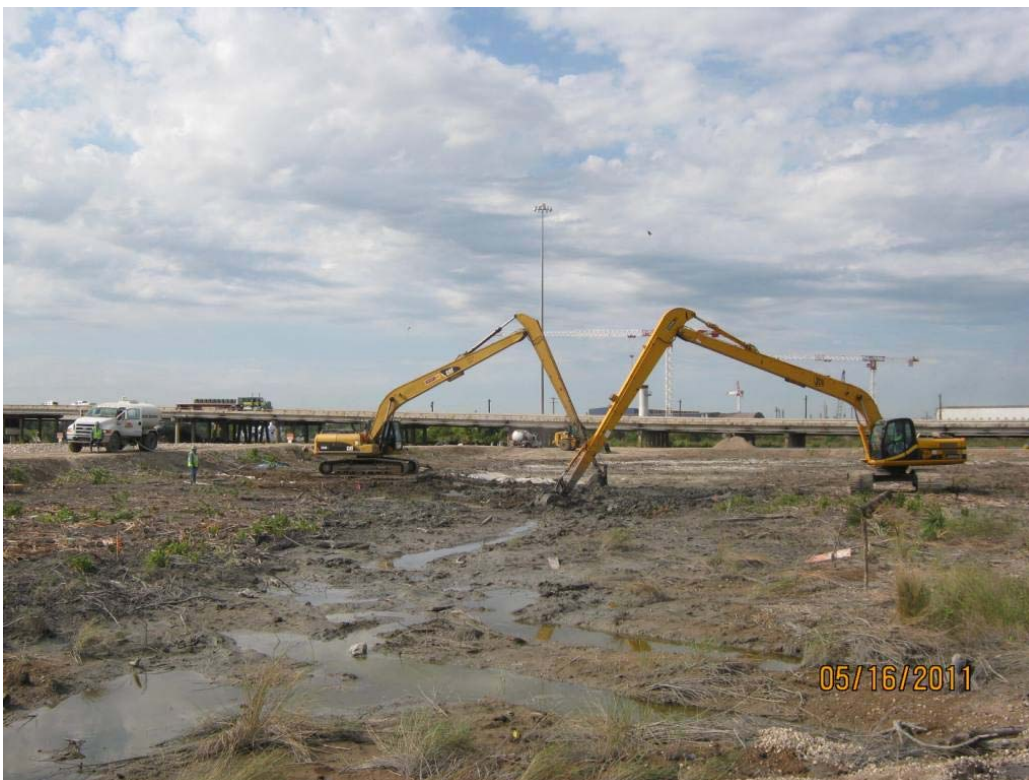
Photo 2 – Mixing Portland cement into a low-lying area in the east portion of the Western Cell.

08:50 Cement delivery truck completed unloading and departed the TxDOT ROW/SJRWP area; USA crew began mixing the cement into a low-lying area in the Western Cell using two long-reach excavators.

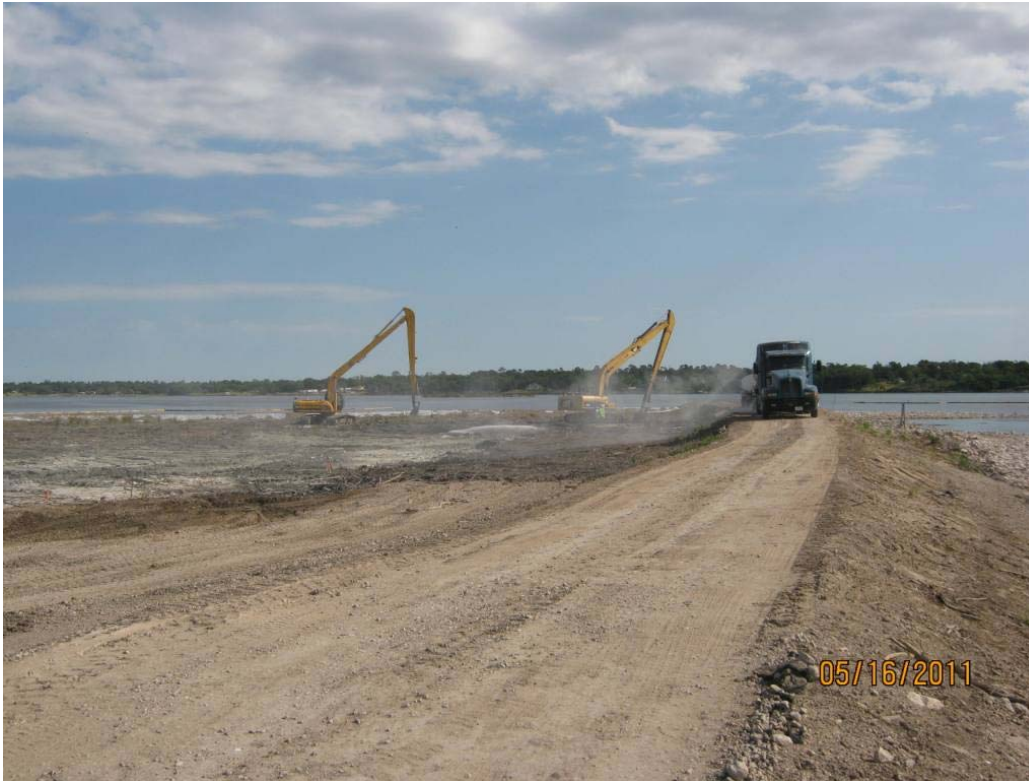
Photo 3 – Delivering Portland cement to the Western Cell.

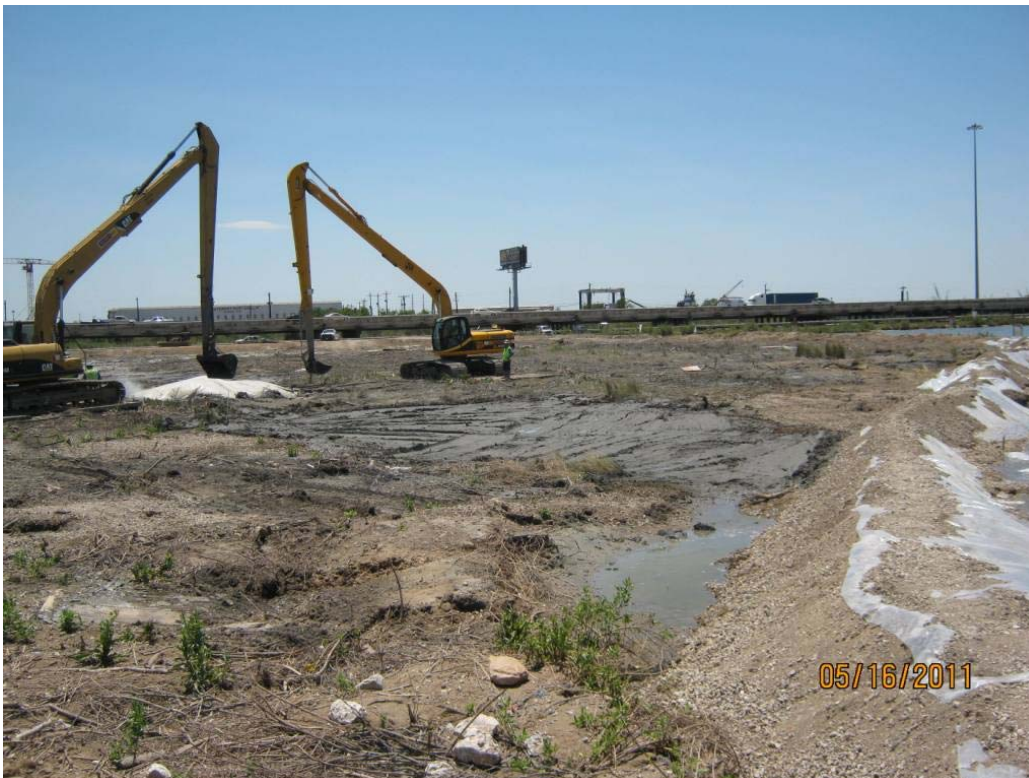
Photo 4 – Low-lying area of the Western Cell shortly after mixing with Portland cement (center of photo) and receiving Portland cement in the Western Cell (under plastic sheeting at left of photo).

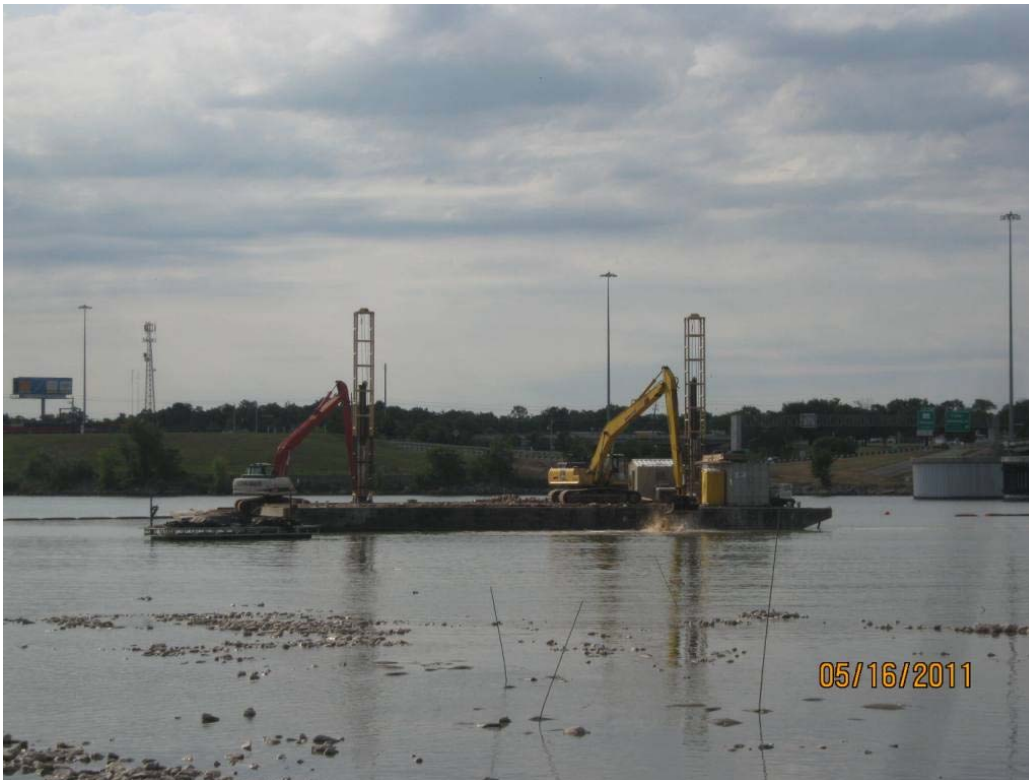
Photo 5 – Placing Armor Cap D rock in the Eastern Cell.

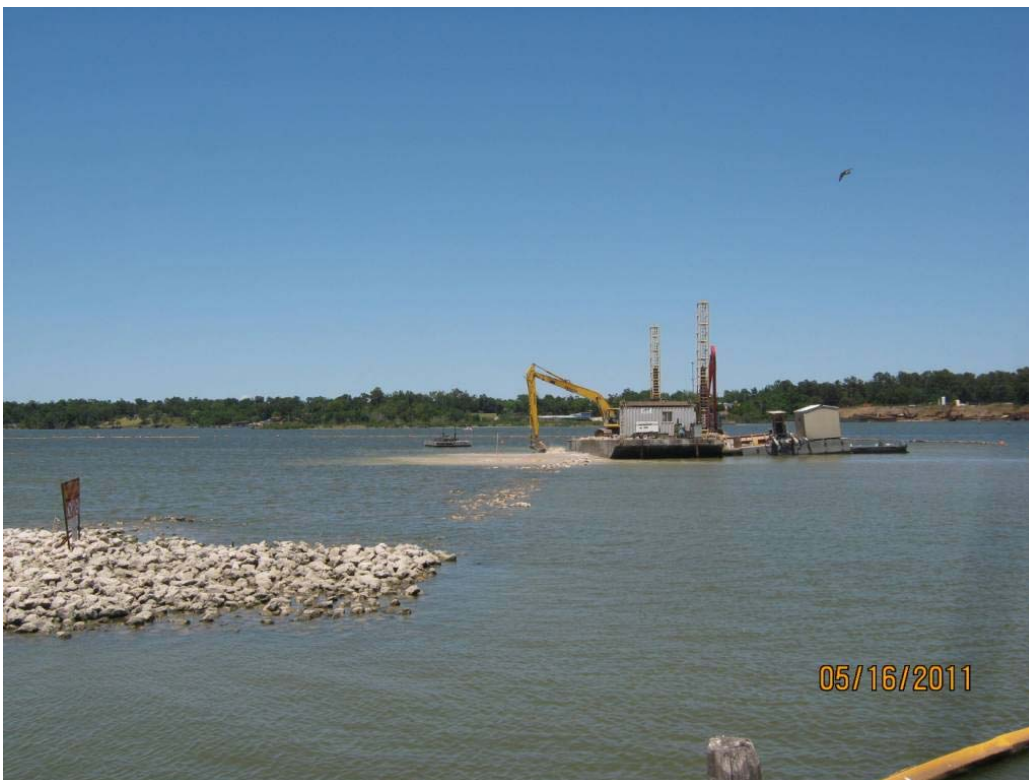
Photo 6 – Placing Armor Cap D rock in the Eastern Cell; note turbidity localized in the area to the left of the barge.

14:10 Visible turbidity from the water-based placement operations is confined to the approximately 75-foot wide area adjacent to the rock placement barge; no turbidity is visually observable outside the turbidity curtain.
